Studies on Tree Pruning in Taichung City: Jian-Kang Park as an Example

Pit-Ngan Cheong¹⁾ Tung-Chi Liu²⁾

Summary

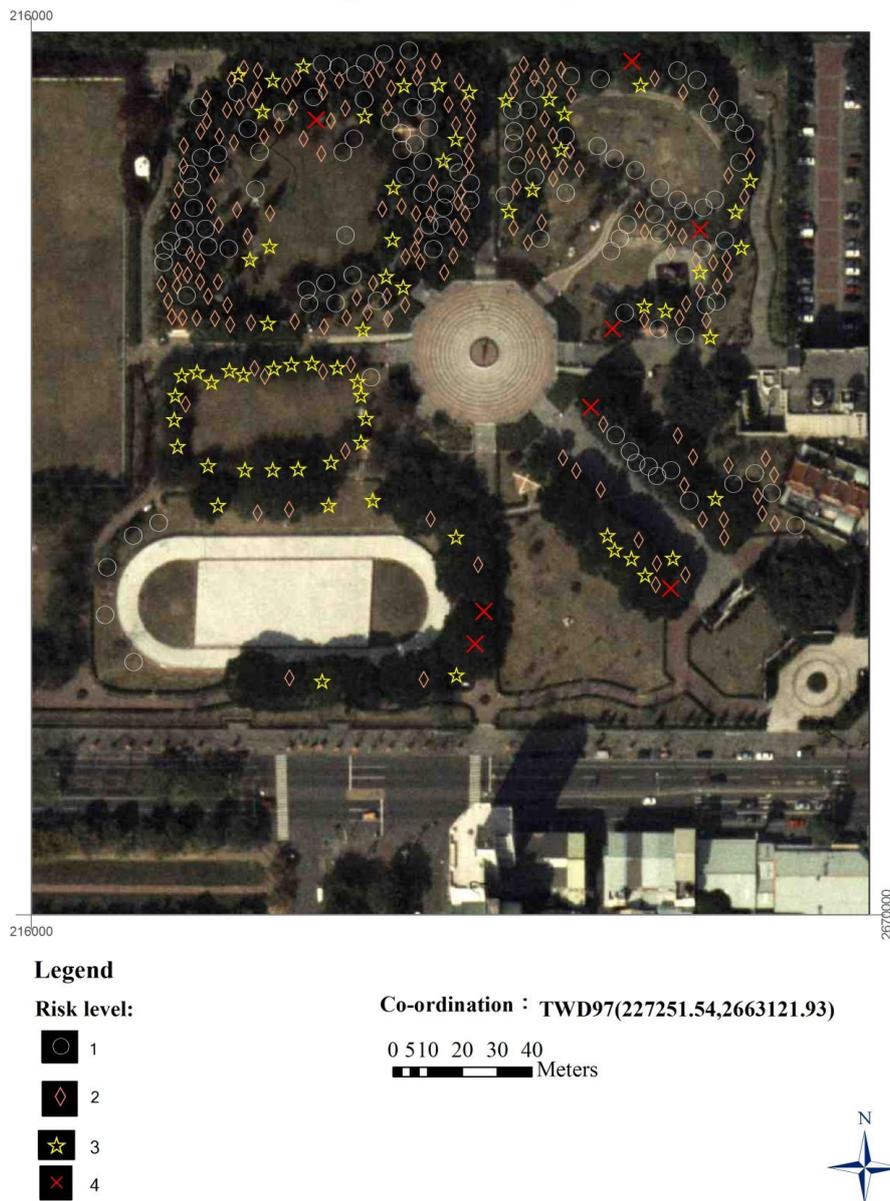
Fig. 1. Mapping of trees according to the risk levels.

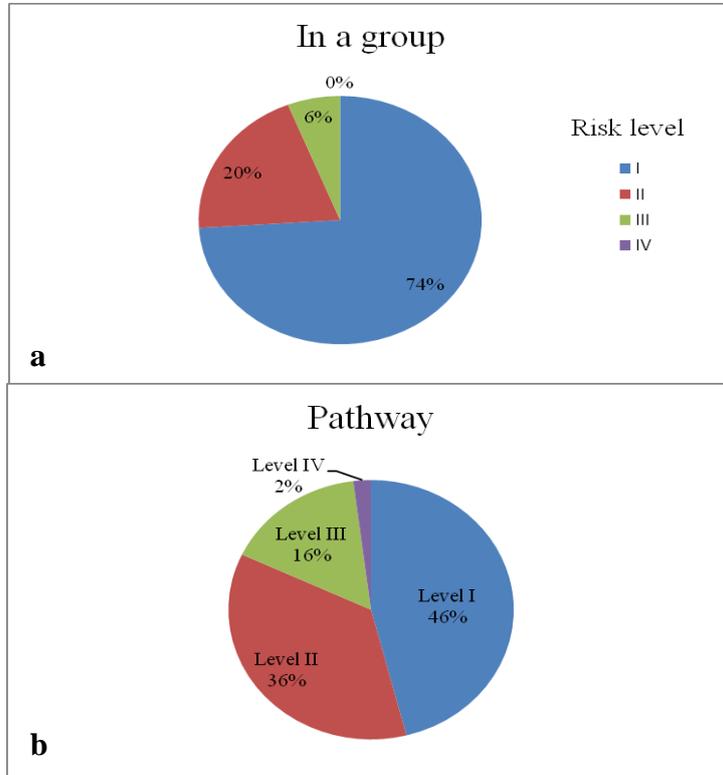
Fig. 2a,b. Different areas in the park with risk level categorization of trees.

A total of 224 trees planted along the pathway. With the consideration that trunk, branches and crown failure will threaten the lives of publics, they were attended with more pruning on crown reduction and risk reduction. However, the more they were pruned, with topping and flush cut method, pathway trees with risk level III and IV found to be more.

Trees under risk level category I mostly had their reduction pruning by tipping at the crown branches (crown reduction pruning) to create a smaller crown. At the same time, group planting showed that trees were pruned lesser and 74% of them fell under level I and regarded fairly safe. ‘Immediate risk’ trees (level IV) were not found under this group. This is because they form canopy to support each other as a group, where as the heaviest part of the tree (crown) were stabilized with high damping ratio within a group, compression forks in dense stands would be able to survive since wind loads in dense stands are limited (Mattheck, 1991).

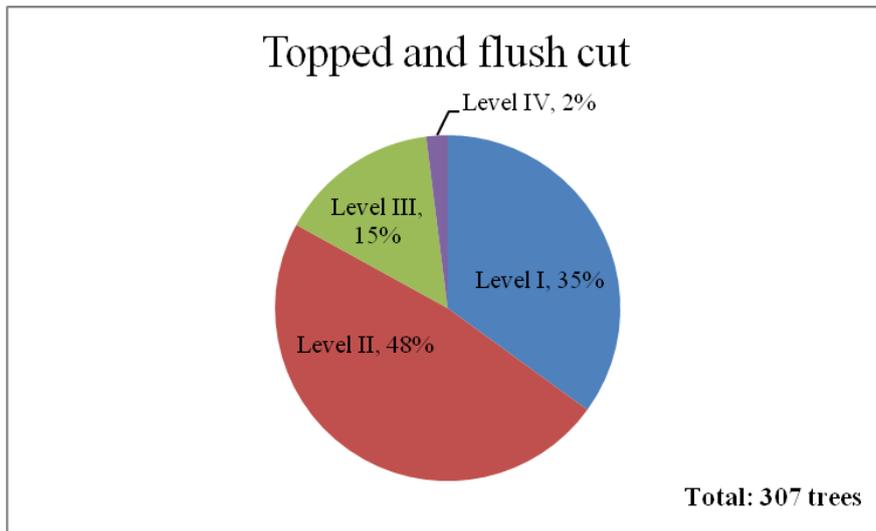
Fig 3. Improper pruning and risk level categorization of trees.

This chart shows different types of improper pruning and how they relate to the risk level of a tree. Out of 354 trees, 87% were found being topped and flush cut, causing decay, cracks and hollow parts, watersprouts which attach at a weak point, asymmetry crown etc. Trees under risk category I were wounded-trees that could not sustain the growth of epicormic shoots; with dried topped parts and stubs, woundwood or decaying spots. Most trees with risk level II, had the presence of watersprouts along tree trunks, crown, where size is very small, small sprouts that bend oddly and were rubbing with other branches and co-dominant branches that form within the crown or at a height not more than 6m from ground level.

Trees under risk category III possess co-dominant branches or multi-stems that grow $> \frac{1}{2}$ size of the originating branch; decay and hollow at the branch attachment point; included bark at the fork that supports high mass above; leaning trunk with dense crown which has a correction growth (branch stretch to the light direction); over-stretch non-tapering epicormic shoots. They can be so dangerous mainly because of the mass they possess and fail easier when loaded under high wind. Trees of risk level III and IV were found to have higher percentage of topping and flush cuts at the same time. These trees usually able to regenerate after topping but the new parts were topped again some time after so to reduce their mass. This cycle is repeated until the tree is too weak to regenerate/reiterate.

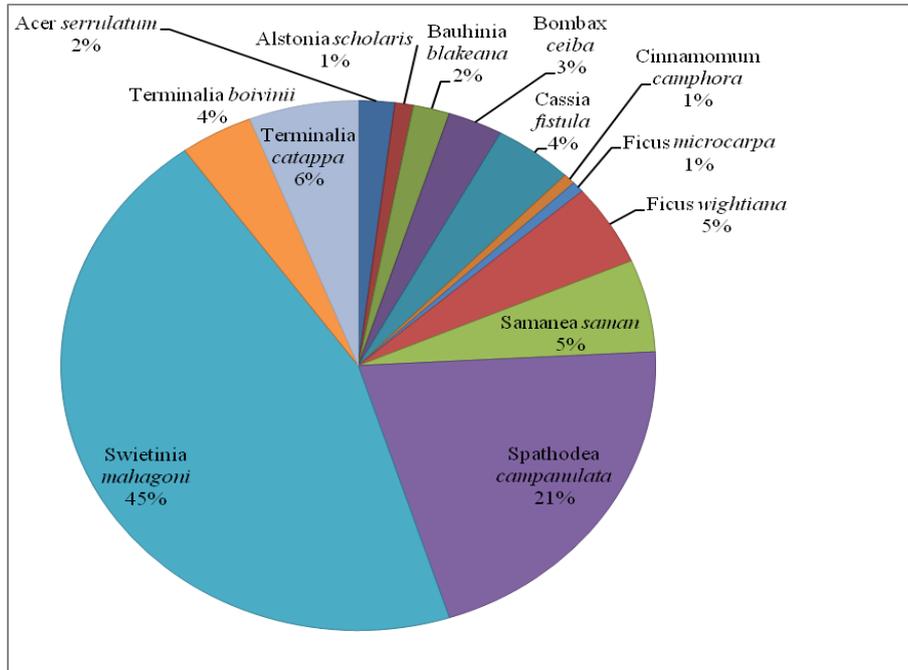
Fig 5. Topped and flush cut tree species with risk level I & II.

Swietenia trees showed high compartmentalization ability under topping and flush cut, with very less amount of trees revealing serious cavities and rotting branches/ structure, contributing to the largest group that fall under risk level I and II. Besides that, group planting also serve to reduce the risk level of this tree species as their crown form canopy that was able to support each other in high wind/rain.

Out of 71 trees, 92% of the *Spathodea* trees were topped and decay spread from the wound. However, 88% of them were still rated under risk level I and II. The main reason is the weak compartmentalization ability of this tree species. Decay that started from the topped area extended down to the trunk flare. Watersprouts struggle from the decaying points and majority of them do not develop into canopy. Some shoots even dried out, as the rotting are not resisted by compartmentalization. This is further supported by DBH data where 75% of the trees have DBH reading less than 30cm, little branching which contribute to sparse crown, smaller foliage size in general.

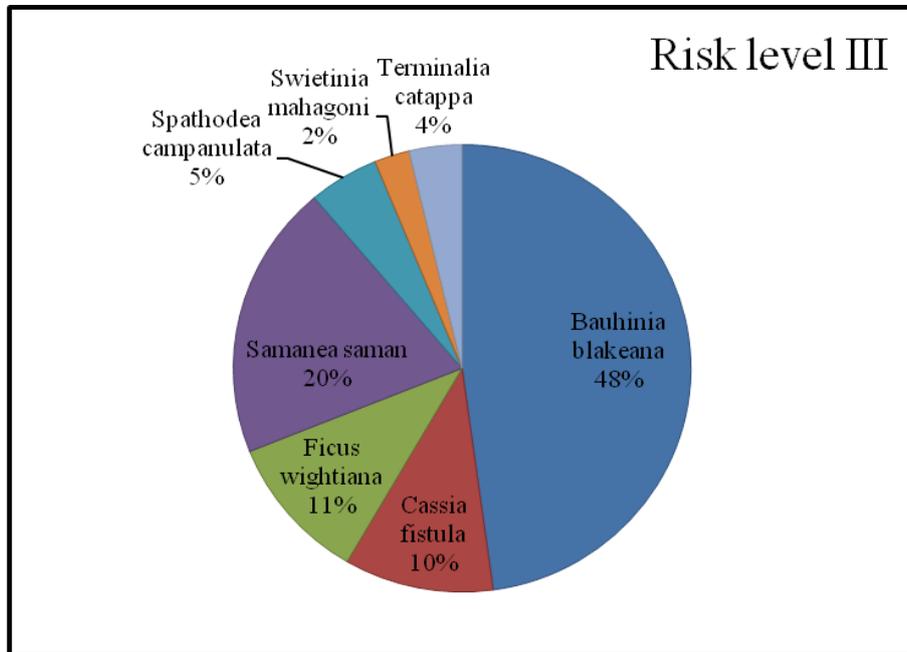
Fig 6. Topped and flush cut tree species with risk level III.

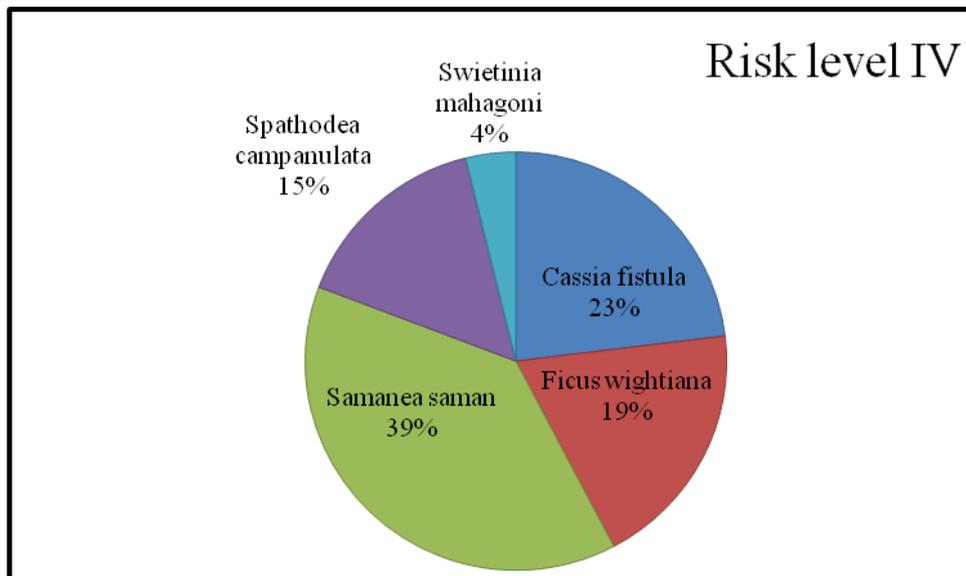
Fig 7. Topped and flush cut tree species with risk level IV.

There were variations in how different tree species react to pruning. Large pruning wounds should be avoided with species that have weak compartmentalization capability, as well as with those do not form branch collars (Einser *et al.*, 2002). Trees species with low compartmentalization ability like Ficus, Spahtodea and Cassia, when receiving repeated topping and flush-cut deteriorate to become 'immediate risk' trees.

Most Spahtodea trees that were topped or had their big branches removed have large decays and wound that spread down to the trunk flare, cavities, numerous dried watersprouts and small DBH reading that delineates stunted growth of the trees. Ficus *wightiana* which were topped develop serious trunk decay. It is the group planting that helps reducing the possibility of mechanical failure of the trees as their crown canopy greatly enhance the damping ratio.

Cassia trees, with smaller trunk and main branches naturally, mostly topped at fork and crown segment. With the fast growing ability and the reserved storage energy, they were still able to carry out photosynthesis process. They react to repeated topping by developing numerous epicormic shoots and vigorous leave-flush. These shoots were found to have compression forks at the upper portion of the tree, high mass, dangerously thin branches, contribute to the risk level IV.

Samanea trees do not fall under the weak compartmentalization tree species. They contributed to the largest percentage of 'immediate risk' group because of the uncountable dried branches and stubs (>5cm circumference) left on trees. As Samanea trees grow fast to have large and long limbs, they were found to be tipped and topped halfway through the branches at whichever branches that were considered to be 'too long'. These branches dried and decayed eventually as they lost all their photosynthesis organ, and being shaded from the sunlight.
